Final Project Report

Capitola Village Drainage Improvement Project

City of Capitola

Proposition 40, Clean Beaches Initiative Grant

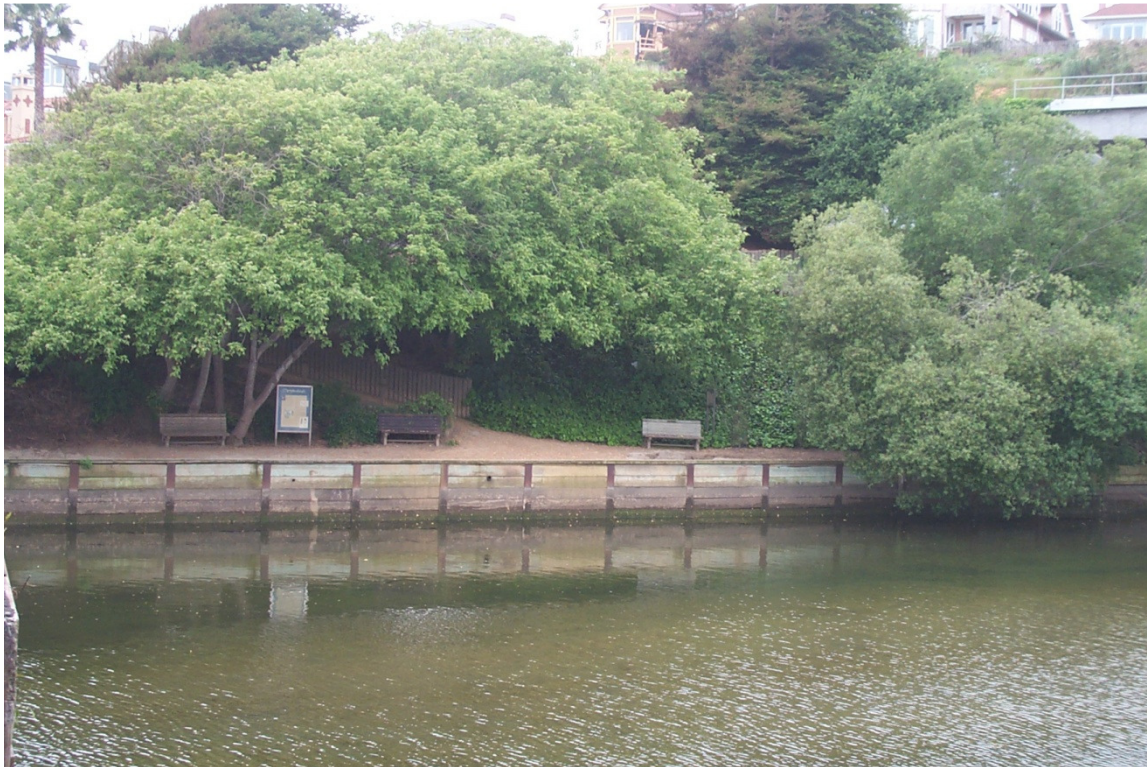
Photo 1 - Site of Capitola's biofiltration wetland prior to construction.

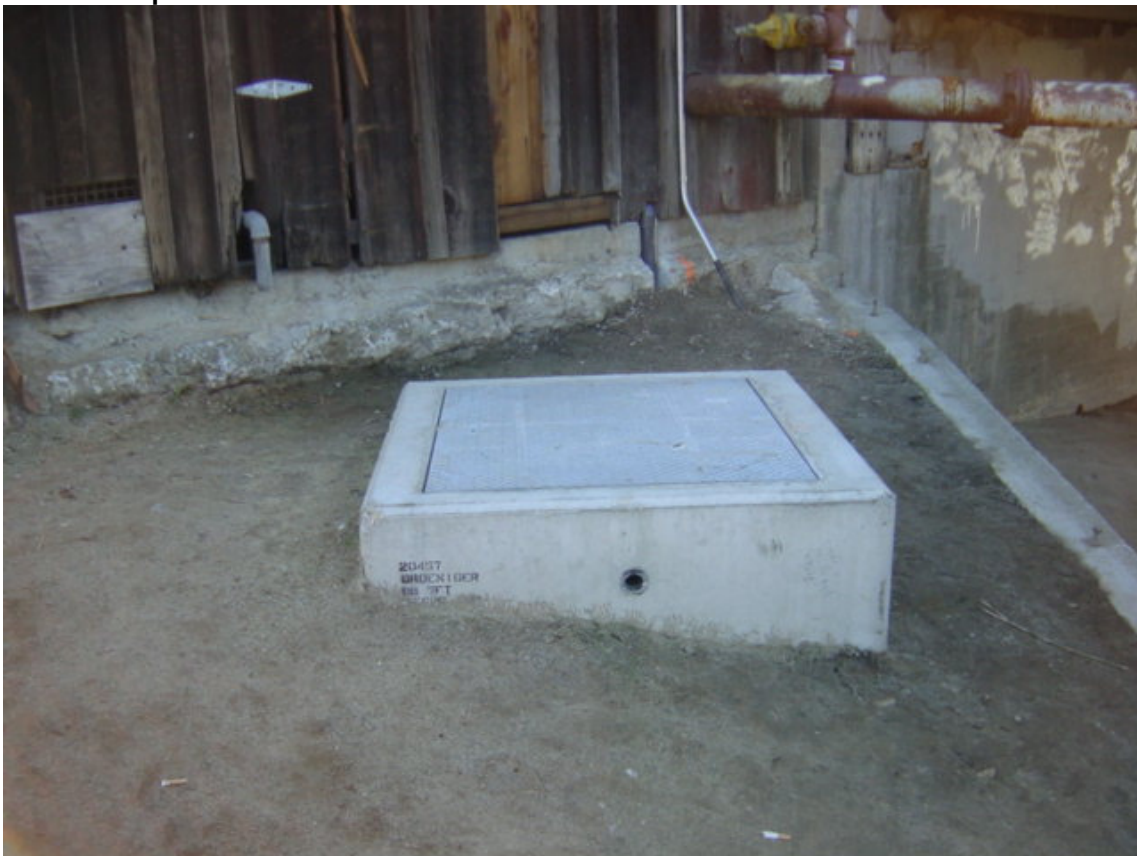
Photo 3: Dry weather stormwater diversion on east side of bridge

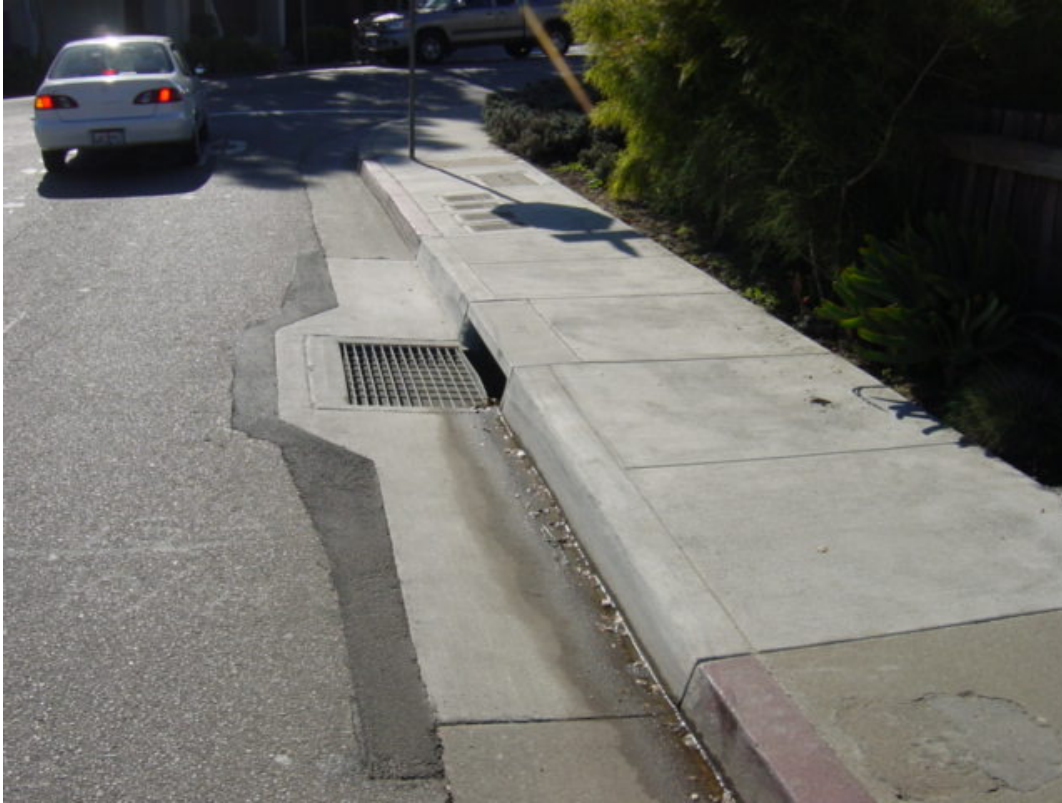
Photo 4: Dry Weather Diversion on west side of creek. This is a gravity diversion where all low flows divert to the wetland.

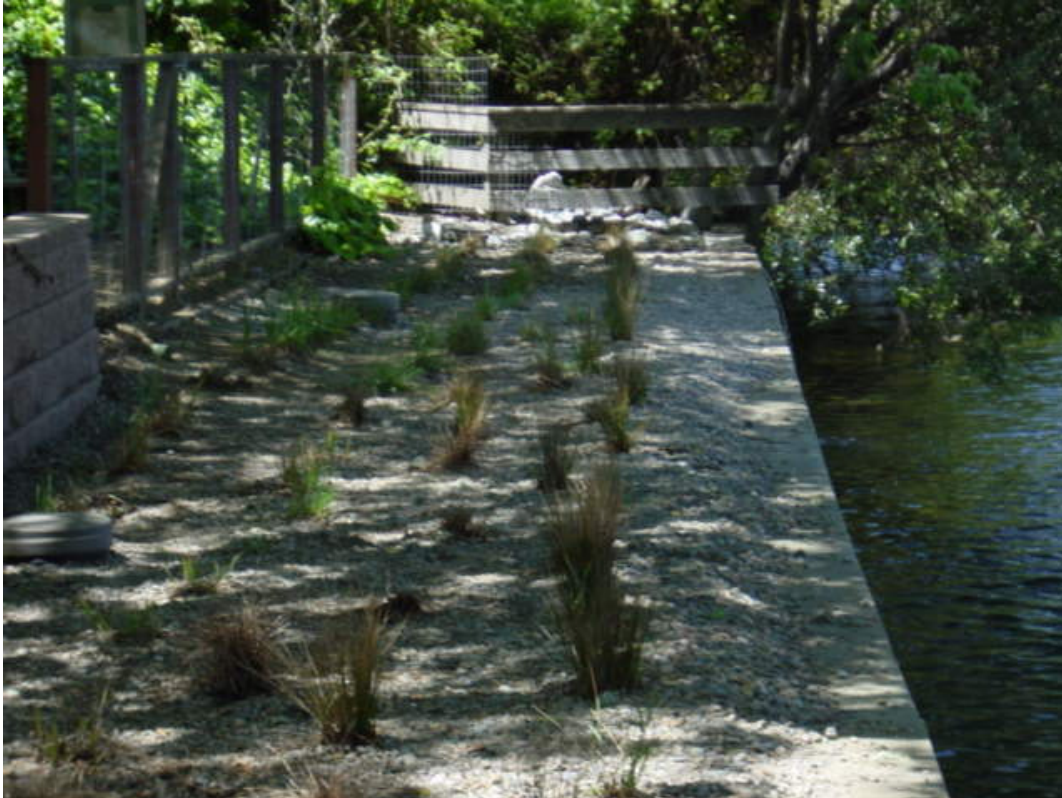
Photo 5: Project area showing new bulkhead and wetland.

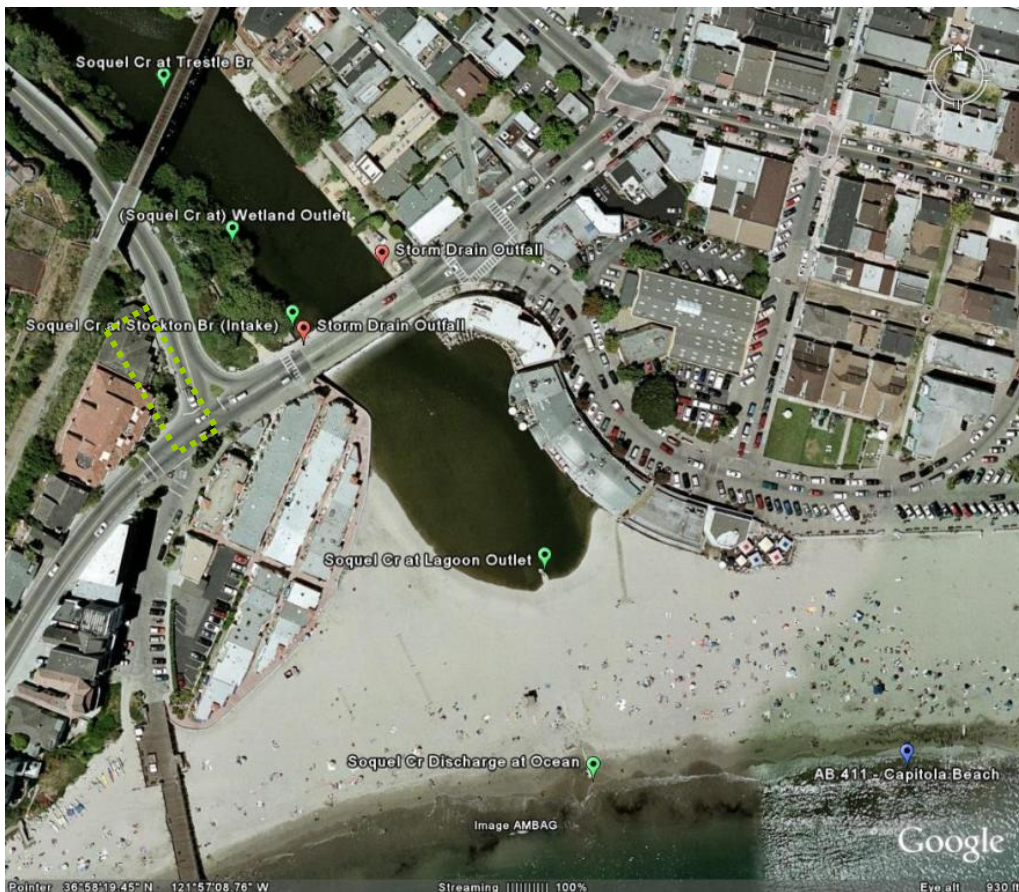
The sites monitored are as follows (see Figure 1):

| 1. Discharge of Soquel Creek at Pacific Ocean | Station ID: 304-SOQUE-23 |
| 2. Soquel Creek at Lagoon Outlet | Station ID: 304-SOQUE-22 |
| 3. Soquel Creek at Wetland Intake (Stockton Bridge) | Station ID: 304-SOQUE-24 |
| 4. Wetland Outlet* | Station ID: 304-CAPWE-01 |
| 5. Soquel Creek at Trestle Bridge | Station ID: 304-SOQUE-25 |

Figure 1. Water-quality monitoring locations.
